# RUSSIAN INTERIM REPORT DETAILS LAST MOMENTS OF FLYDUBAI BOEING 737 CRASH AT ROSTOV

**The Russian Interstate Aviation Committee published an interim report, detailing the progress of their investigation into the cause of the fatal accident involving the flydubai Boeing 737-800 at Rostov Airport on March 19.**

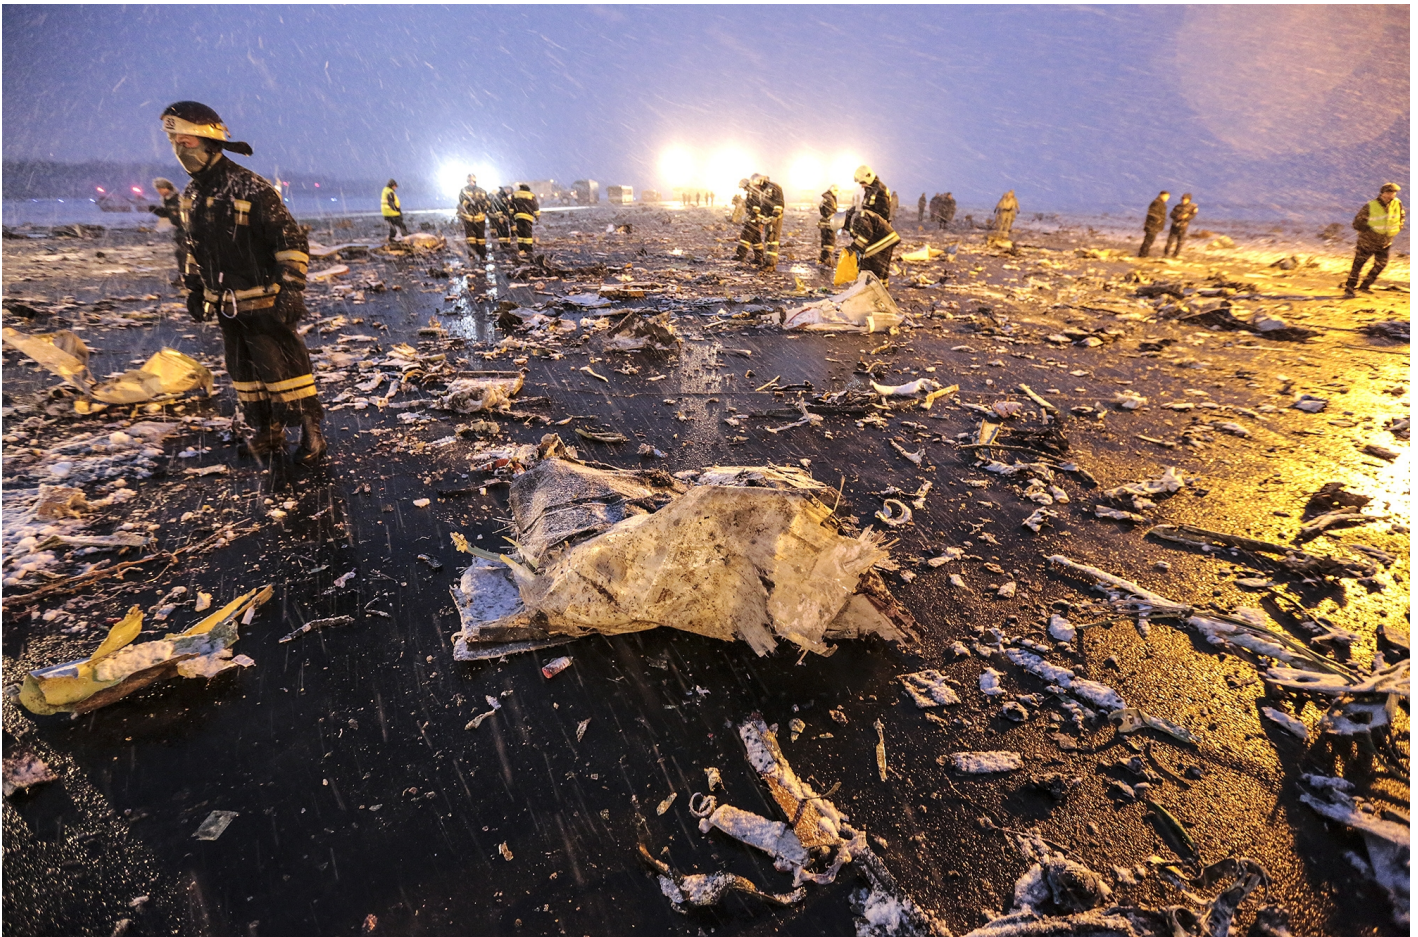
## Reconstruction of the aircraft (IAC)
