# THE ARCTIC ELEPHANT: AVIATOR DE-ICING OPERATIONS IN TROMSØ

News / Airports / Routes

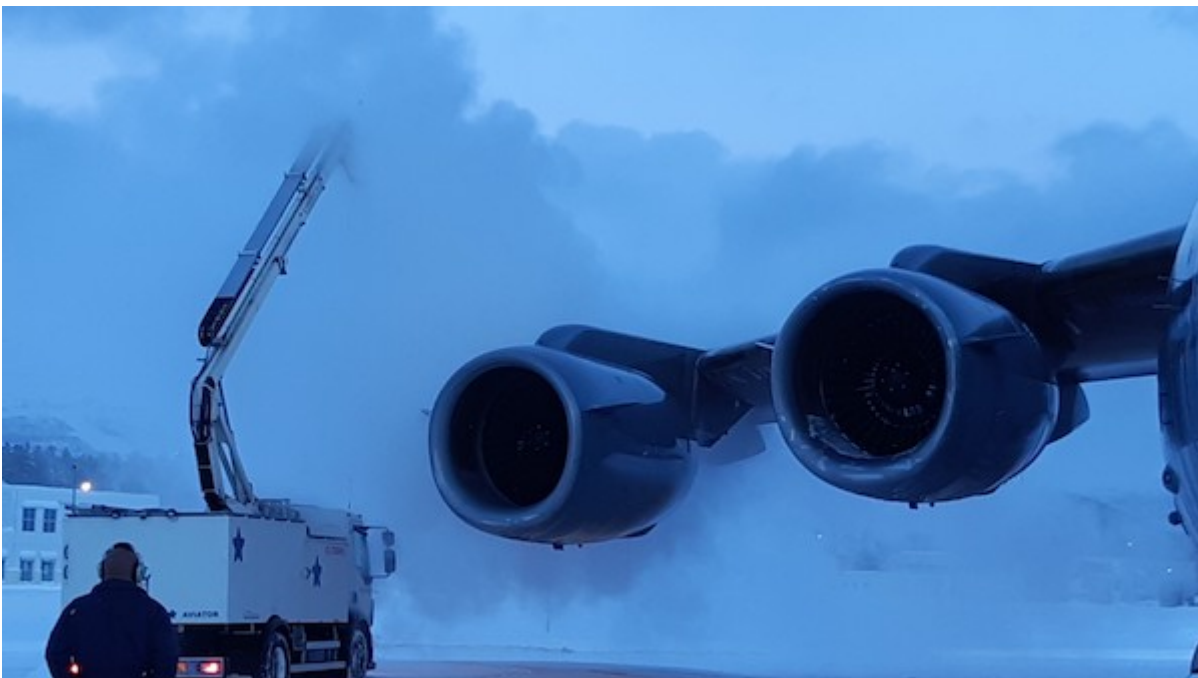
The de-icing and anti-icing procedures require expert knowledge and experience as they incorporate human input through heavy machinery. The specialist machinery involved is the Elephant BETA-15 – affectionately known by the team as ‘The Arctic Elephant’. The Elephant BETA-15 has the longest reach capacity of any standard mobile de-icer in the world, and is the heaviest handling equipment utilised by Aviator. The de-icer can provide a working height of up to 15 metres, with an extending telescopic reach of 12 metres ensuring safe, efficient, and effective operation at all times.

The vehicle is equipped with 3 spacious tanks which contain water and propylene glycol. The first tank contains hot water, the second contains heated Clariant safe wing MP1 eco plus 80 (type 1), and the last tank contains cold Clariant safe wing MP 2 flight (type 2). The onboard proportional mixing system blends the type 1 solution with the hot water for use in the first step of a two-step de/anti-icing procedure. The type 2 solution remains unmixed and is used in the second step of the two-step procedure. The fluid’s high viscosity maximizes the overall holdover time (the time between de-icing and take off). Additionally, throughout the procedure, both type 1 (red) and type 2 (green) have different colourations, enabling the operator to differentiate between the fluids and ensure that the correct fluid is applied in each procedure.

A standard de-icing procedures using two ‘Arctic Elephants’ – managed by de-icing operators in a one- or two-step procedure – takes between 5 and 10 minutes. “A one-step procedure is usually done during clear weather conditions and uses heated, diluted fluids to de-ice and anti-ice the aircraft in one step,” explains Truls Torgersen. “The two-step procedure, which gives the aircraft a longer holdover time depending on the severity of the snowfall and size of the aircraft, is accomplished in distinct and separate steps where the de-icing and anti-icing treatments are conducted with thicker fluids to prolong the aircraft’s protection from contamination. The first step removes the frozen contaminants, such as snow, frost, and ice using de-icing fluid. The second step is the anti-icing - where the plane is treated with anti-icing fluids.”
